Re-engineering of Stators of Three phase Traction Motors type 6FRA 6068 used in WAG9/WAP7 locomotives for Improving their Reliability

R.N.Lal ,Senior Executive Director Standards , Ganesh , Director Standards
Electrical Directorate , Research Design and Standards Organisation , Lucknow

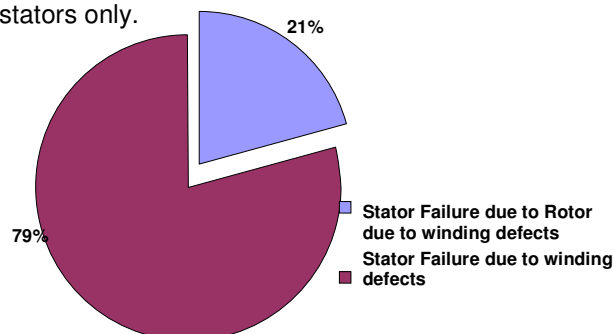
- 21% failure of stators is on account of rotor bars crack and balance 79% is exclusively on account of stators only.

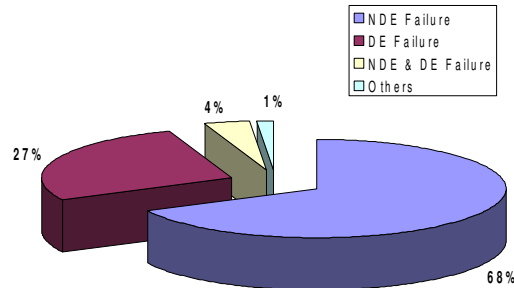
- If we analyse location wise stator failure , it is 68% on NDE side whereas just 27% on DE side.

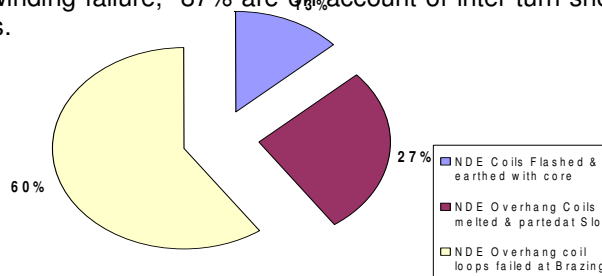
- Out of these ,NDE side winding failure, 87% are on account of inter-turn short on overhang or brazing failure on joints.

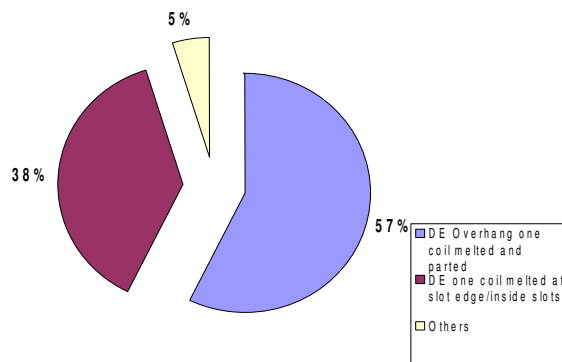
- Similarly , DE end failure has also been analysed and 95% failure is contributed by grounding with slot and failure in overhangs

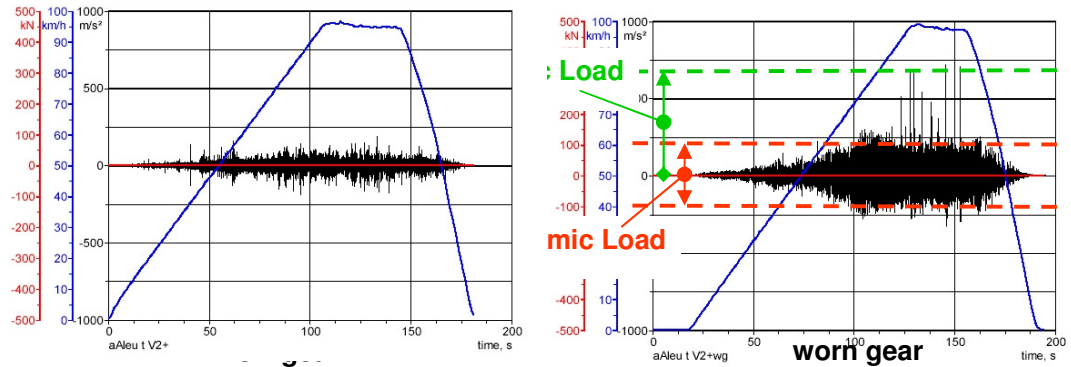
- Even with new pinion , shock and vibration level goes upto 14 g against the design assumption of 8-10 g in dynamic loading condition.

- Shock level multiplies by three times (40g) with worn out pinions (BTL-77.68). Because of excessive wear in pinions and its inadequate supply, the pinions are running with further low value of BTL (77.68 to 77.42)
- With worn out pinion , shock and vibration level goes upto 89 g against the design assumption of 30g in static loading condition.

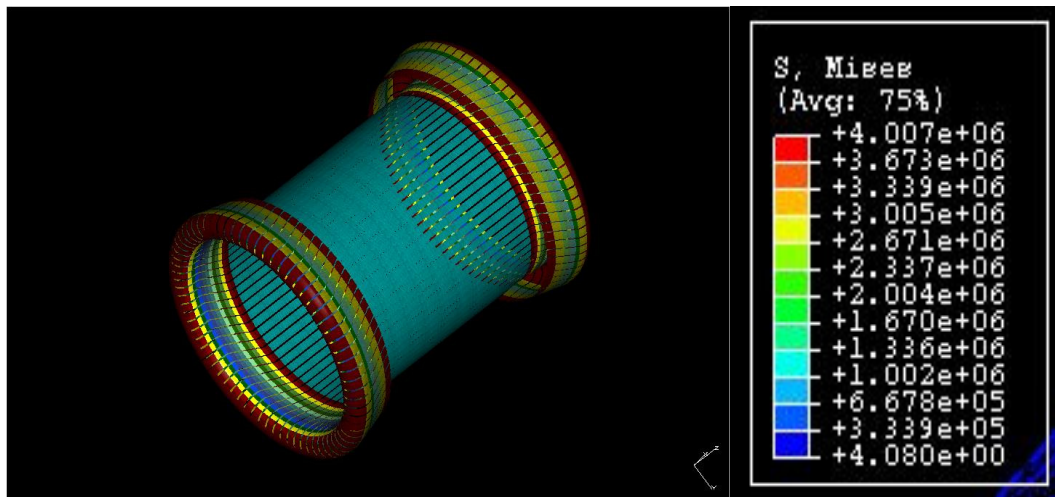
7.3.2.1. FEA of Stators with original overhang arrangement , i.e without any support:

Analysis matches with the failure data. More stresses are coming on the winding overhangs near slot ends and its free portion . Red colour shows location of maximum stresses and dark blue location with least stress.

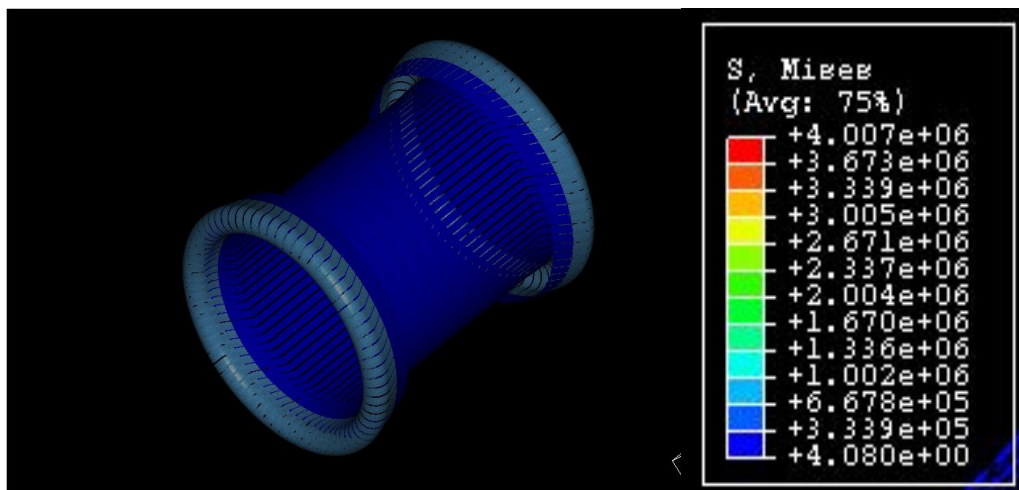
7.3.2.2. FEA of Stators with overhang support arrangement at eight locations as proposed by M/s SAINI in Proposal I: Because of uniform support at eight locations which anchor winding ring , stresses on winding overhangs is eliminated.

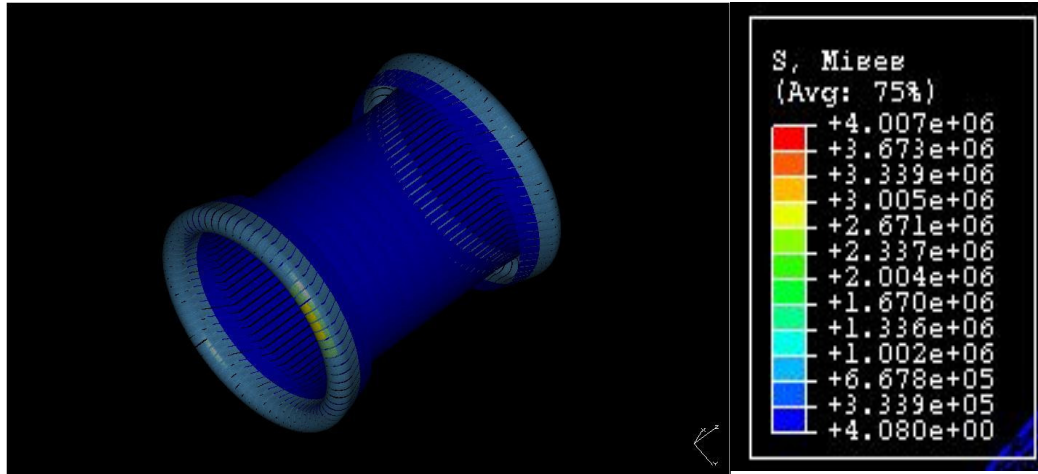
7.3.2.3. FEA Results of Stators with overhang support arrangement at seven locations as proposed by M/s BHEL in Proposal II: Because of the support at seven locations which anchor winding ring , stresses on winding overhangs has reduced drastically , at all the locations except at one location i.e. near terminal box. There are some elements with yellow zone of stress.
