Soochna, March 04

Study of defects & corrective actions

Failure investigation reports

**Diesel Locomotive Works
Indian Railway
Varanasi**

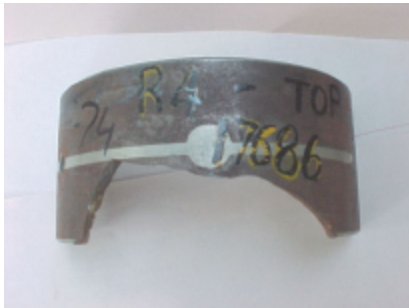
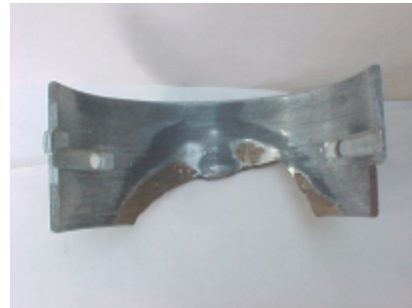
Marking on the broken bearing is KOEL 12 99 G. It had broken into two pieces. Photograph showing the breakage is printed below,

The central portion of the plated side shows biased wear in the area which had broken and separated.

Shed had also sent the corresponding bottom bearing. Marking on this bearing is KOEL 10 99 H. There was no abnormal wear or peel off in this bearing. Both these bearings, however show abnormal scoring and impregnation of foreign material on the plating surface.

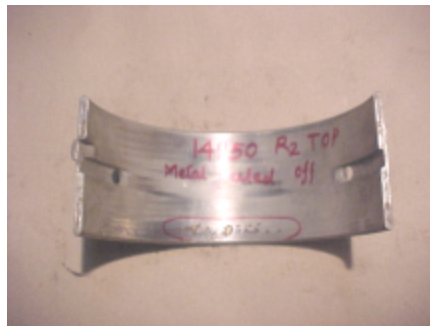
Marking on the above bearing is GMH 05.01. The photograph of the failed bearing, which is printed below shows pitting and progressive crack of the bronze layer in about 4"x1" area in one corner. There is no evidence of any abuse of the bearing. Even the plating does not show any wear, except few small networks of cracks (in plating) in the same area where pitting of the middle layer has been observed.

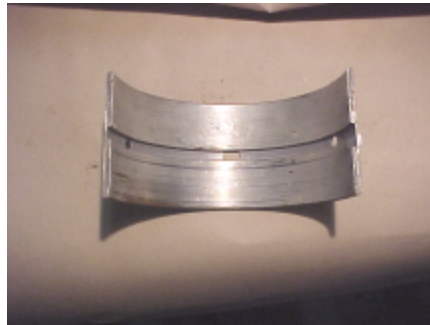
Marking on the M.B.Shell is GMH indicating that it is Gletlager make. Several scoring marks; some of them quite deep; were noticed on the plated side of the above bearing. There was no evidence of wear, but about 5% of the plating had peeled off from the area which was badly scored. Photograph of the damaged shell is printed below.

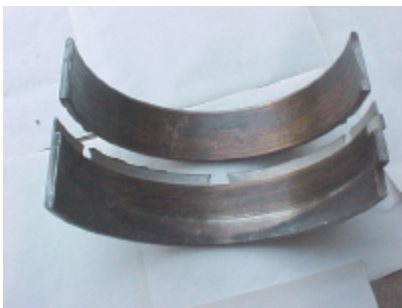
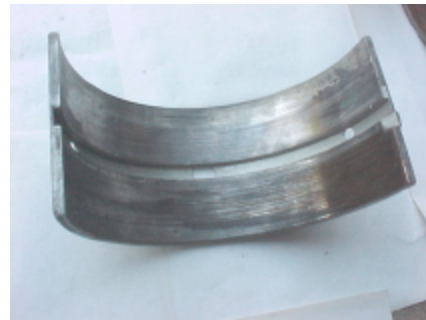
U3 and L3 bearings were sent to DLW for investigation. Marking on them indicates that they were of GMH make. The upper bearing revealed scoring of over layer in half of the bearing making streak mark. There was no any other damage. The lower bearing had broken into two parts from the oil groove. Machining of the groove showed absence of radius at the change of section. Its plated side revealed biased removal of over layer and streaking in the middle layer. The wear was excessive in the affected half side towards one of the edges. The bronze layer viewed bluing besides deep and numerous scoring marks. There was evidence of miner fretting on the bearing back; but lugs were in good condition. Photograph of both the bearings is printed below,

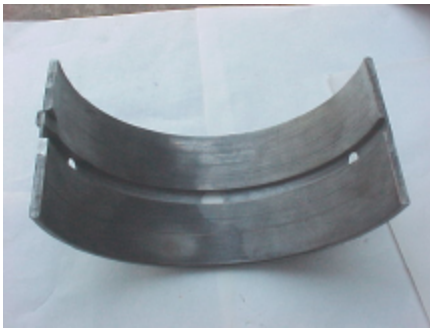
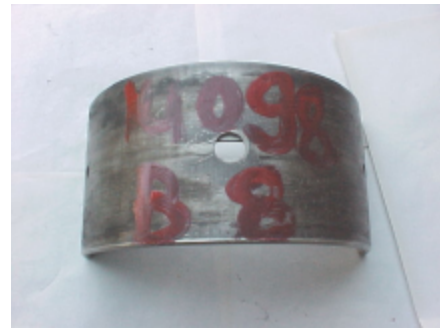
Marking on the bearing is GB 08 01. Examination of steel back side revealed slight fretting and examination of plated side revealed blackening in about 30% of the surface area in center besides several deep scoring marks all over. No failure of overlay or of the middle layer was noticed. Photograph of the above bearing is printed below,

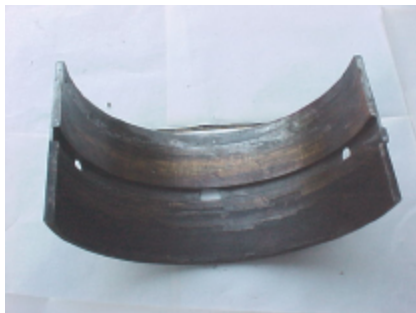
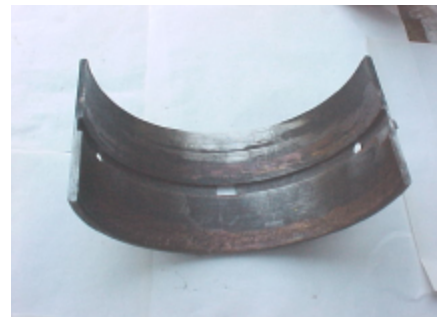
Marking on both the bearings is KOEL 02 02 1470. Both of them show blackening in one half side of the oil hole, excessive wear of the plated and fusion & fatigue failure of sintered layer. Only about 20% area in one of the bearings did not show any wear. Lugs of both the bearings are undamaged. Photographs of these bearings are printed below,

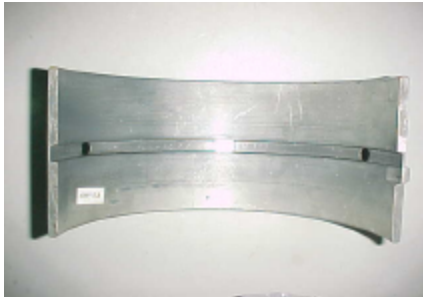
LOCO NO. 17397 T-3

Marking on the bearing is GB.06 00 INT 10150018, P003. Photograph of this bearing is printed below,

Visual examination indicates that, the bearing has several deep scoring marks & the tin flash has peeled off from about 10% of the bearing surface. There is no other damage like layer peel off or chip out.

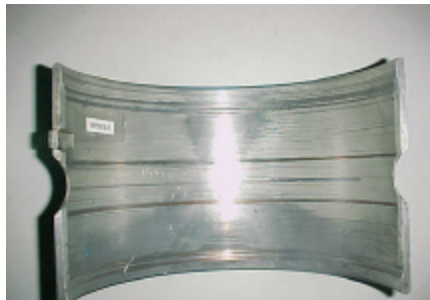
LOCONO. 14958 T-5

Marking on the bearing is KOEL 10, 01 10150020.

There are several very deep scoring marks on the bearing surface, besides slight exposure of the bronze in between two of such scoring marks. The tin flash also is thick. There is no evidence of layer peel off or chip out.

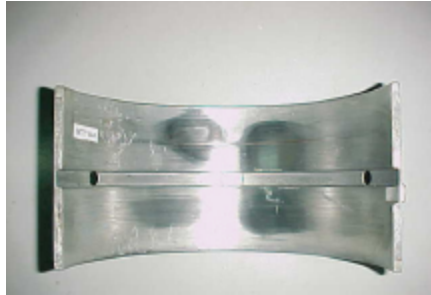
LOCONO. 16777 B-9

Marking on the bearing is GB 01, 02 INT 10150018 P 007. Photograph of the bearing is printed below,

Visual examination shows that the bearing surface has blackened at four spots. This black spot is surrounded by wear marks. There is also evidence of deep scoring mark at one place and few scratch marks at places. The bearing however does not show any evidence of layer peel off or chip out.

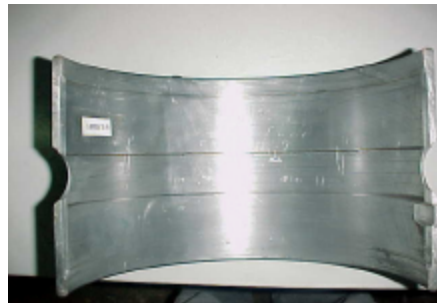
LOCONO. 14958 T-5

Marking on the main bearing is KOEL 10 01 10150020 .

There are several deep scoring marks on the bearing surface. Otherwise, there is no evidence of peel off or chip out.

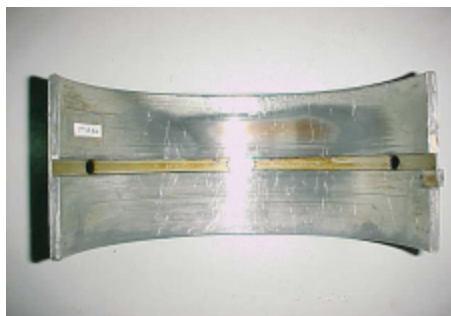
LOCONO. 17715

Marking on the bearing is GMH 12, 99, 10150018.

Bronze layer of this bearing is exposed in the middle in about 4"X1" area. There are several –several deep scoring marks. No evidence of layer peel off or chip

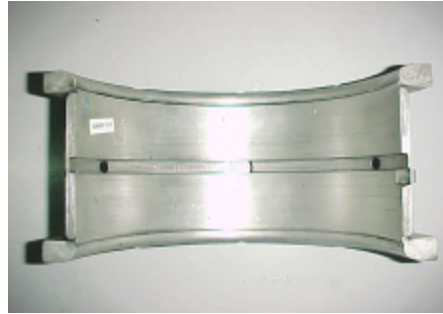
LOCONO. 14949 T-9

Marking on the thrust bearing is GB 10, 00 10150031 .

The bearing surface shows negligible distress. The bearing shows crack in the fillet of the collar .

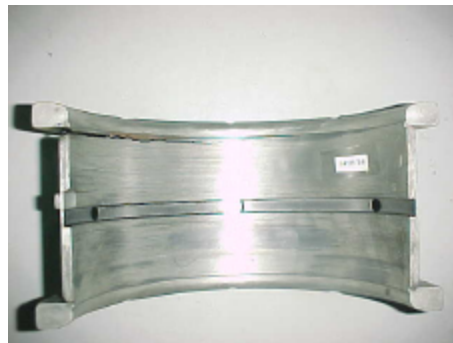
LOCONO. 14735

Marking on the thrust bearing is GB 01, 001 10150031.

This bearing also shows crack in the fillet of the collar. There is otherwise no evidence of any damage.

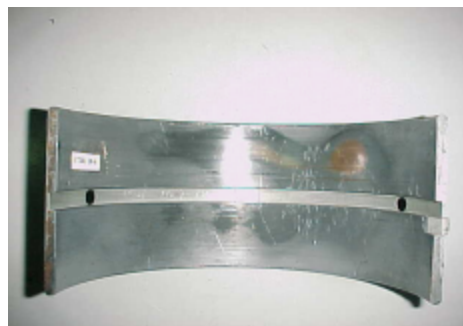
LOCONO. 17261 B4

Marking on the bearing is GMH 12, 99 10150018.

Bronze layer is exposed in about 15% of the bearing area. Steel back shows lack of proper contact with the housing. There are several shallow scoring marks. There is no evidence of any layer peel off or bearing metal chip out.

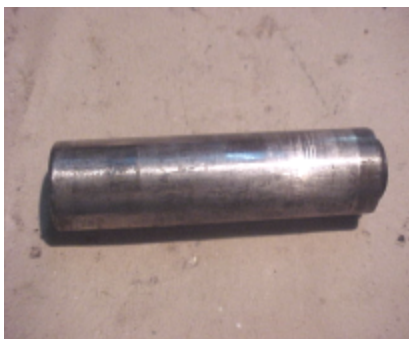
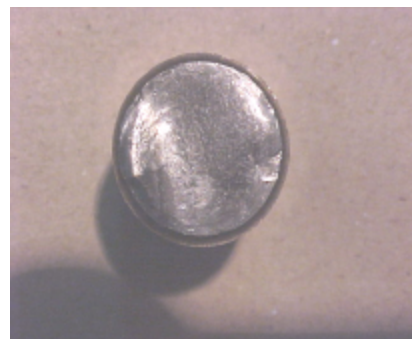
Both the pieces of the broken cross head body pin were received. There was no identification mark on either of them. One of them was pressed in the retainer. Fractured faces of both the pieces were smooth. When examined under magnification, beach marks associated with fatigue type cracks were not visible. The fractured face looked to be smooth due battering. Patches of crystalline failure were noticed in between the battered areas. There were several notches on the outer side of the fractured surface. Photographs of the above two pieces are printed below,

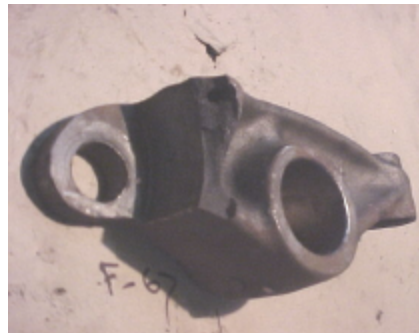
Marking on the cross head lifter is 2002, R, 10140931 E-2. Its one flange was broken from change of section. The fractured face is crystalline. There is evidence of one half inch long crack at the radius of this change of section. Also there is evidence of sharp change at this radius. Photograph of failed cross head lifter is printed below,

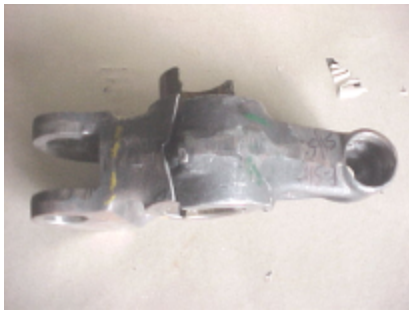
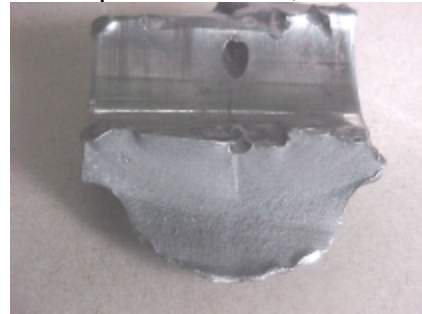
Marking on the fuel pump lifter is SFL-SF05, 668, 10140931. It had broken into two pieces from center. Photograph of the broken lifter is printed below,

About 40% of the fractured faces are smooth, remaining areas are crystalline. Associated bushing also had broken in two pieces. Photograph of the one of the pieces is printed below,

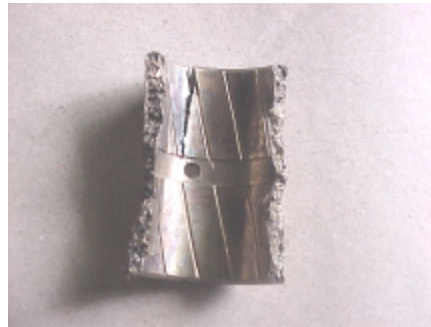
There is no evidence of any casting defect or abnormal wear. Its failure appeared to be consequential. Detailed analysis of this bush was therefore not taken up

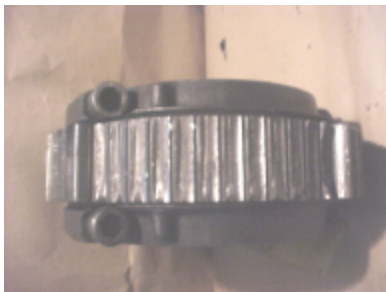
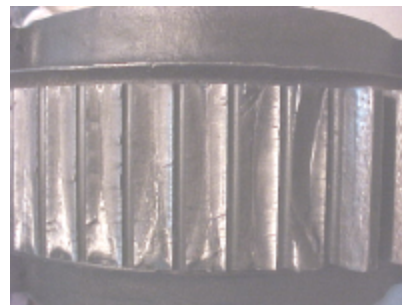
Marking on the split gear is DLW 796. Thirteen of its teeth were broken. Photograph of the failed split gear is printed below.

Fractured surfaces show varying degree of progressive cracks, being around 70% in the first of the broken tooth. These cracks had started from root fillet. Almost every one intact tooth shows abnormal wear and abnormal pitting in addendum and dedendum.

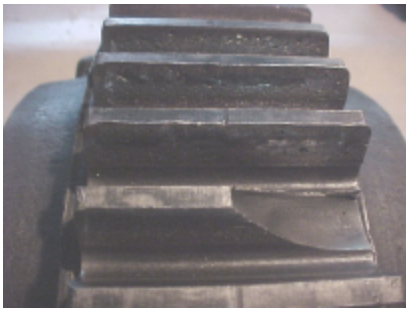
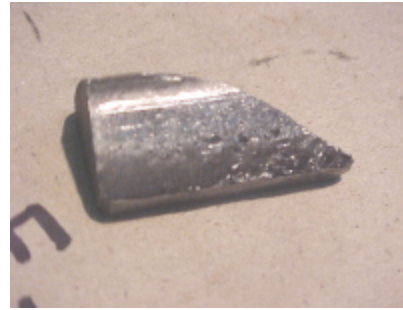
Marking on the broken gear is SFL 977 DLW4116. One of the teeth was found broken. The fractured face revealed fatigue crack initiated from one side of the root. Most of the teeth revealed severe pitting and plastic flow of metal. The pitting and plastic flow however was not one sided. Photograph showing the breakage and pitting is printed below,

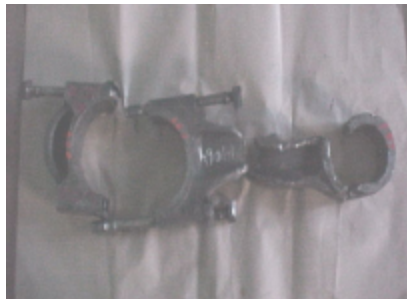
Marking on the connecting rod is SIFL (03/01) 1015 D 0107 DCW. Photograph of assembled pieces of broken connecting rod is printed below,

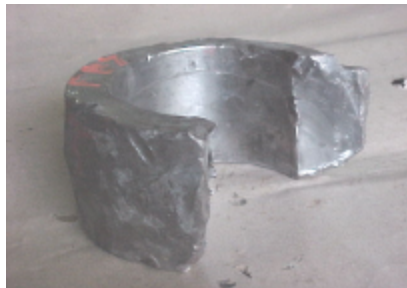
It had fractured from two locations. The fracture in the web area is battered and the fracture in the small end area shows about 70% progressive crack. Photograph showing this fractured face is printed below.

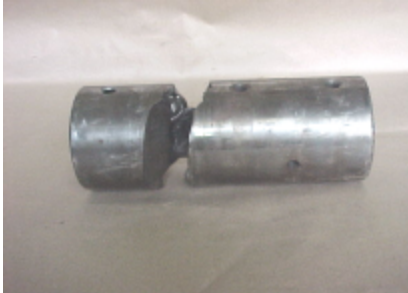
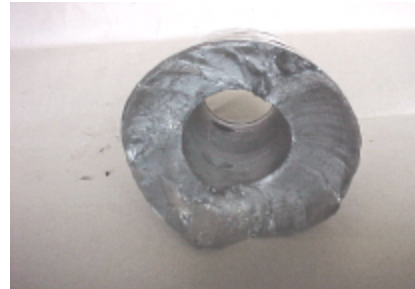
The marking on the broken piston pin is DC-98. It had broken into two pieces. Photograph of the broken pieces is printed below,

The smaller of the above two pieces revealed presence of a longitudinal crack extended up to the lubricant hole. This crack was opened by saw cutting from the other side. The opened surface showed presence of multinuclear progressive crack. On further examination under magnification it was noticed that several micro cracks were present on the boundary of case and core encompassing the corner of the lubricant hole, from where the progressive cracks had initiated. Machining marks also were noticed in the bore of the lubricant hole.

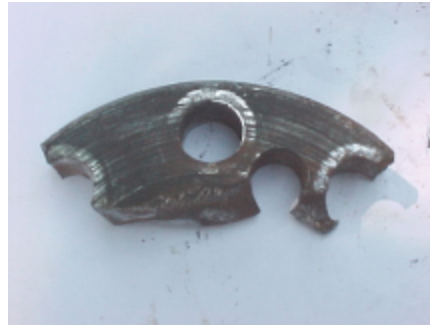
Only a small piece covering about 3" of circumferential length was received. There was no identification mark on the sample. Photograph of the broken pieces of flange is printed below,

The bolt hole shown above is enlarged. Inner face of the flange is showing deep machining marks. The fractured face shows about 25% fatigue crack, about 25% final rupture and the remaining area is battered.

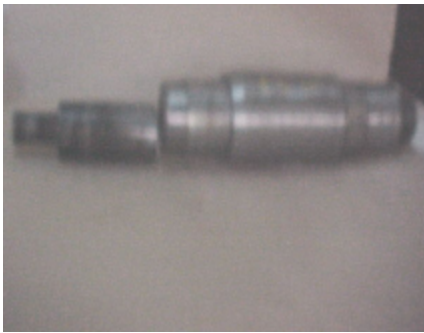
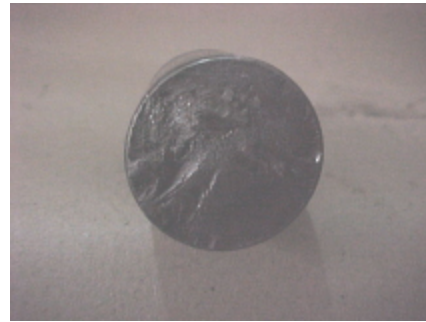
There was no marking on the shaft. It had broken from a change of section at the location where oil seal bush is pressed on the shaft. The fractured face shows multinuclear fatigue crack (about 65%) initiated from a sharp change of section. Photograph of the failed shaft in assembled condition and the fractured face is printed below,

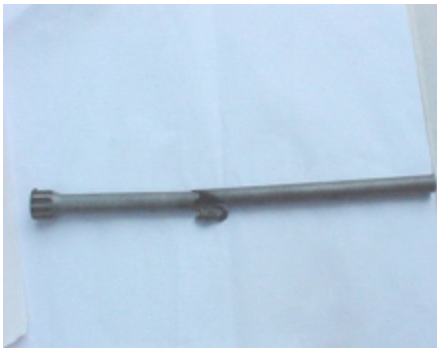
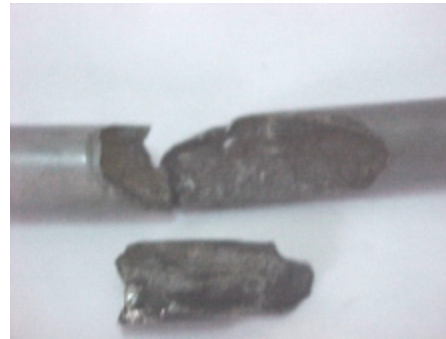
Marking on the broken spline is 5.2K 96. It had broken into three pieces about 6 inches away from the gear end. The fractured face is crystalline. The failed sample also shows abnormal wear and damage to the teeth of the spline at the gear end. Photograph of the broken spline in assembled condition and also the fractured faces is printed below,
