Action Plan to Arrest Breakage of Brake Lever Assembly in WAP7 Locomotives

R.N.Lal ,SrEDSE ,M.K.Gupta ,DSE

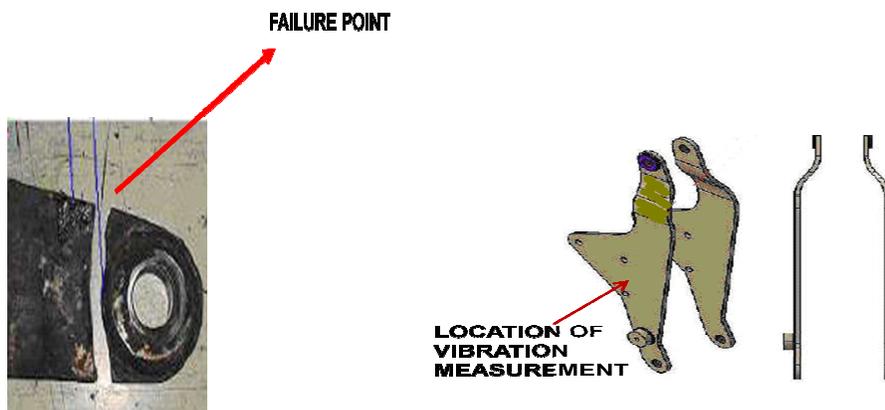
Failed Bracket

- 2.1. 100% of the breakage took place at the top of the hanger plate and just below the welding done for fixing of additional ring to enable fixation of bush of 20 mm width.

The initiation of crack begins from the welded portion near the bush. This gradually develops and results in failure from that point over a period of time due to fatigue.

Five (5) nos. of failed samples of brake hanger of WAP7 were sent to Metallurgical & Chemical Directorate of RDSO for investigation and confirmation of microstructure, chemical composition etc. to IS: 8500 Grade Fe540B. During micro and macro structural examination, it is found that there is a formation of bainite in the alloy steel

which is more brittle in the heat affected zone. The breakage of lever arm is attributed to presence of bainite and martensite at heat affected area due to improper welding execution. It is observed that the breakage have been taking place from the heat affected zone due to excessive heat generated during the process of welding. This excessive heat generation may be due to wrong selection of electrodes, high current and non-standard procedure of welding techniques for welding structural steel as per IS: 8500. Therefore, the causes of failures in all the brake hangers are same.

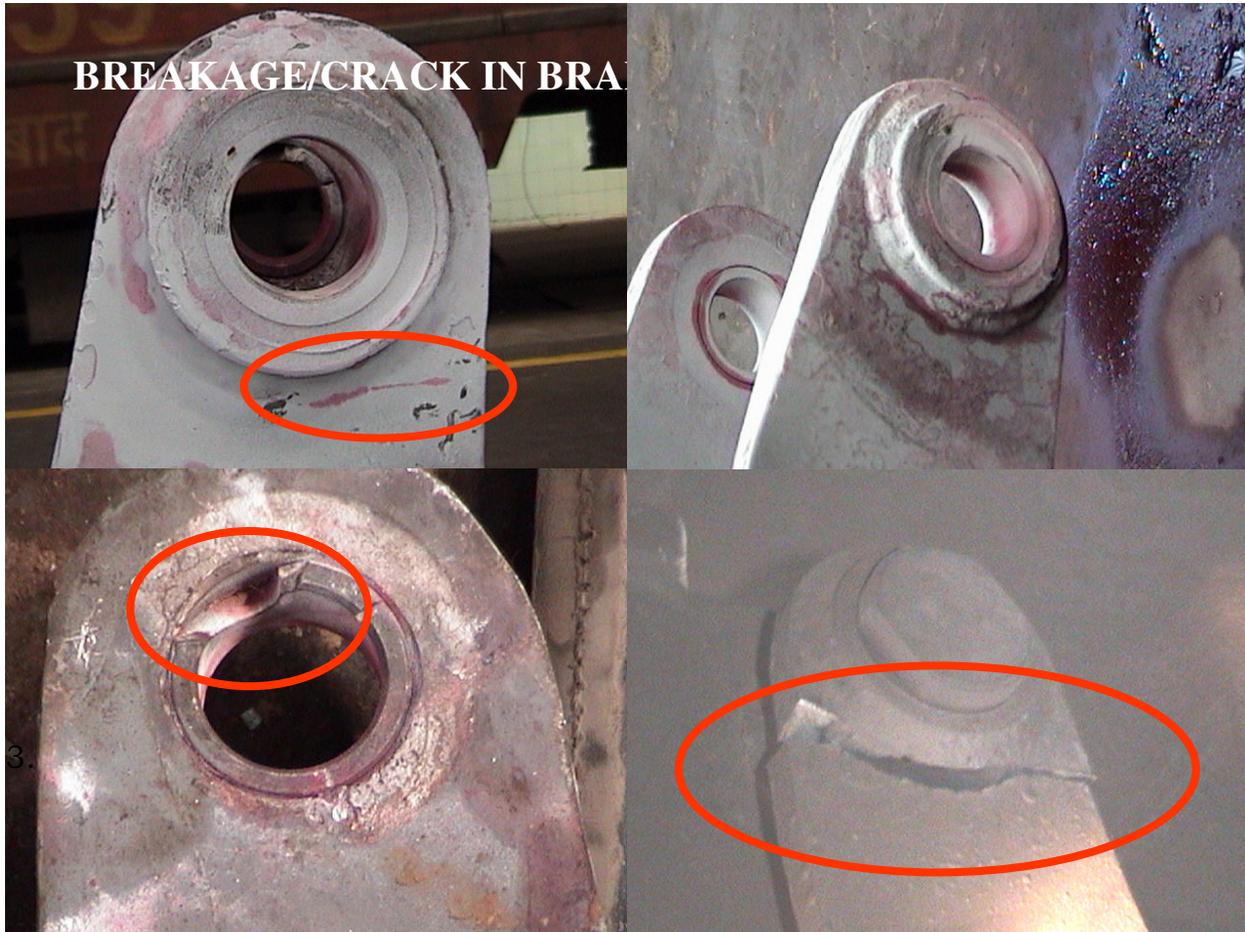
- 2.2. Both the inner as well as outer hangers are breaking. However, the cases of breakage of inner hangers towards bogie frame are much more which 80% of the total failures.

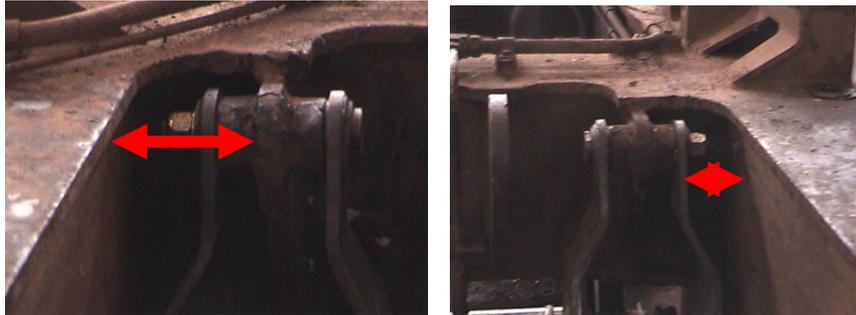
VARIABLE CLEARANCE BETWEEN BOGIE FRAME AND BRAKE HANGER

- 2.5. The gap between outer hanger and bogie frame is found to be as low as 4 mm in place of designed value of 13 mm. Such cases of low clearance are found only in CLW built bogies. The flaws in the jigs & fixtures of bogie frame at CLW during manufacturing process has already been identified by CLW itself and corrective action has been taken for WAG9 & WAP7 locomotives.

- THE DISTANCE BETWEEN TUBE (WHERE THE BRAKE HANGER PIN IS PROVIDED) AND BOGIE FRAME IS VARYING FROM (136mm TO 152.0mm).

In the CLW built bogie, there is excessive play between pin and the bush of the tube (bracket) from which complete brake unit (TBU & PBU) is suspended. To solve this problem of fast wearing of bush and parent material of tube itself, corrective action has been identified and taken at CLW. The material specn. of the tube in vogue was as per IS:2062 in place of requirement as per IS:8500 Grade Fe540B. The material selected for brake hanger, as per IS:8500Fe540B is in line with the original specn. of AS:3678 in terms of its chemical composition and mechanical properties and the same has been verified too.

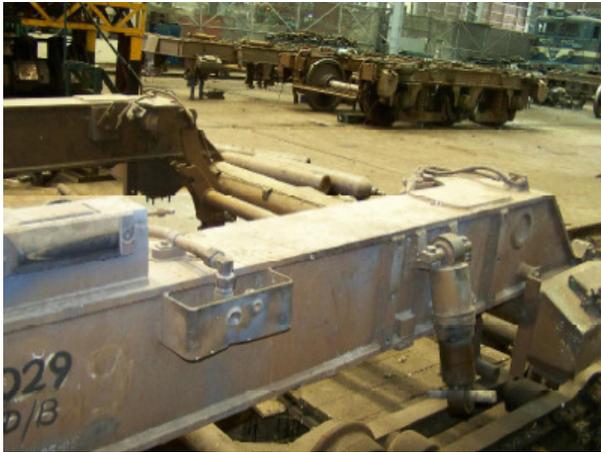
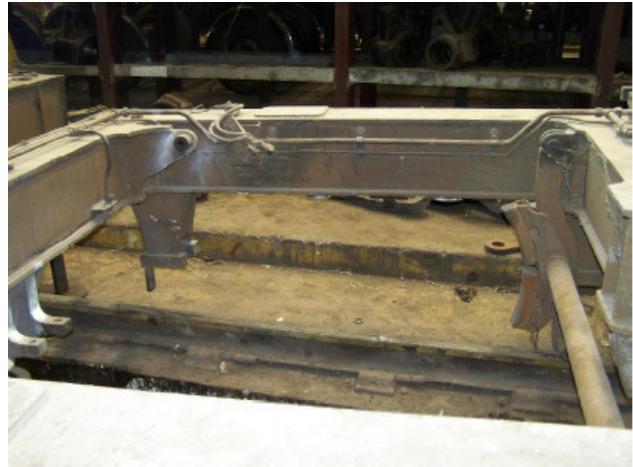
Unmodified bogie frame

The above work needed precise welding, heat treatment of bogie and alignment of brake rigging. Therefore one loco set (2 bogie frames)was modified with the help of a bogie manufacturer. The photos of unmodified and modified bogie frames are shown below:
