SHED – DIESEL SHED, GONDA

I. BRIEF HISTORY

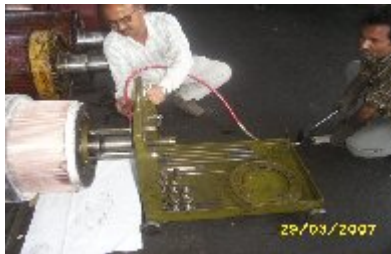
8. Design and Fabrication of Mechanical puller for Traction Motor end Fittings:-

Traction Motor end fittings were removed by gas heating. This practice suffered from various drawbacks. Hence a work-group was formed and detailed technical analysis was carried out to find out solution to the problem. After detailed technical deliberation, different mechanical puller has been designed and fabricated by technicians themselves.
