Re-engineering of Stators of Three phase Traction Motors type 6FRA 6068 used in WAG9/WAP7 locomotives for Improving their Reliability

R.N.Lal ,Senior Executive Director Standards , Ganesh , Director Standards
Electrical Directorate , Research Design and Standards Organisation , Lucknow

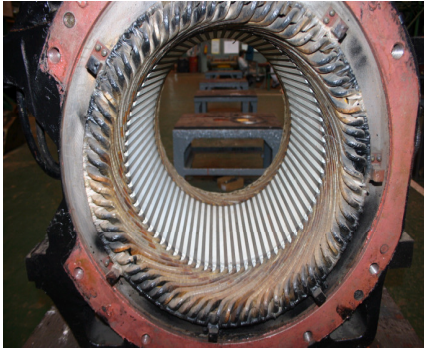
SIEMENS DIESEL LOCOS TM

6.2. SIEMENS, Toshiba , Alstom, MELCO and GE are having similar concept of supporting stator overhangs.
